# “Image Science and Analysis Group Spacecraft Damage Detection/Characterization”

NASA Lyndon B. Johnson Space Center, Houston, TX  
Astromaterials Research and Exploration Sciences (ARES)

Ira M. Wheaton Jr.  
MUST Program  
Mentor: Tracy Calhoun  
June 1, 2010 – August 6, 2010

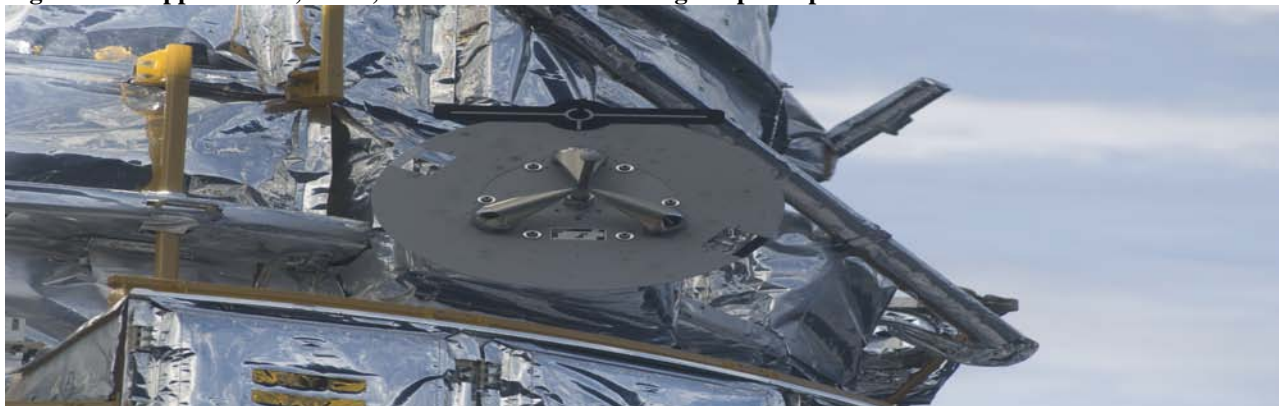
**Figure 2: Grapple fixture, ID 87, which was measured using the pixels per inch calculations in Table 1.**

This project focuses on using different mathematical and geometrical techniques to create an image scale in pixels per inch for images taken from a shuttle in orbit. Using the direct scaling method, we were able to determine how to scale photographs that are taken and recast the calculations for individual photos.

**Table 1:** Shows (x,y,z) coordinates for Shuttle Windows and ID points. Also, shows the magnification calculations in pixels per inch, based on the distances and vectors from the windows and ID points, unit vectors above ID points, & angles between the vectors.
